MOSQUITO RUN DAM

NDI No. PA01012

PHASE I INSPECTION REPORT
NATIONAL DAM INSPECTION PROGRAM
PAC N31-81-C-0011

Mosquito Run Dam, Lycoming County, Pennsylvania
NDI No. PA 01012, PennDER 41-2
Mosquito Creek
Inspected 1 April 1981

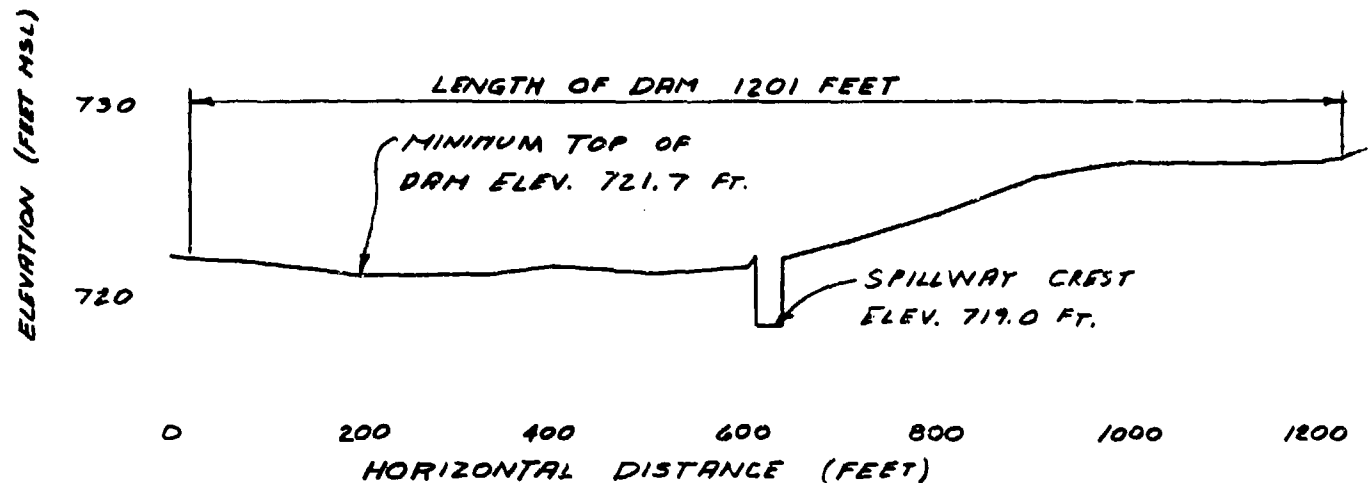
TOP OF DAM PROFILE (LOOKING DOWNSTREAM)

VISUAL EXAMINATION OF	OBSERVATIONS	REMARKS OR RECOMMENDATIONS
VERTICAL AND HORIZONTAL ALIGNMENT OF THE CREST	Horizontal and vertical alignment are good except for the low area noted on the Field Sketch (A-13) and top of dam profile (A-14). Minor vehicle tracks were present on the crest of the dam.	The upstream end of the embankment was constructed higher than the downstream end. Fill and seed the low area and the tire tracks on the crest of the dam.
